Manhole Inspection Summary

Manhole # S33C__054MH

Insp Date: **8/27/09 1:38 PM**

Location Address: **REAR OF 400 HOWARD ST** Cross Street: **MULBERRY ST**

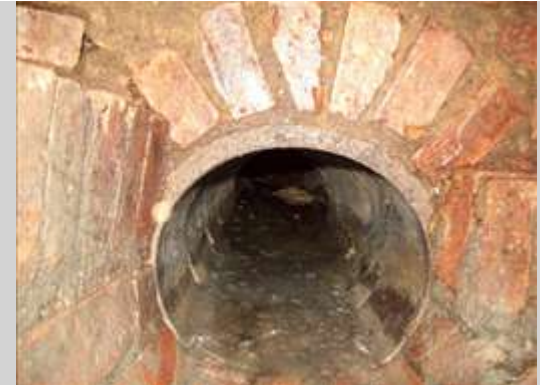
12 O'Clock Outflow

8 in. Circular Gravity Sewer
Pipe Out @ 12 O'Clock

Pipe Material: **DIP/CI** ☐ Pipe Lined

Invert Depth: **14.18** (ft.) Flow Characteristics: **Slow**

Infiltration: **None**

Pipe Seal Cond: **Sound**

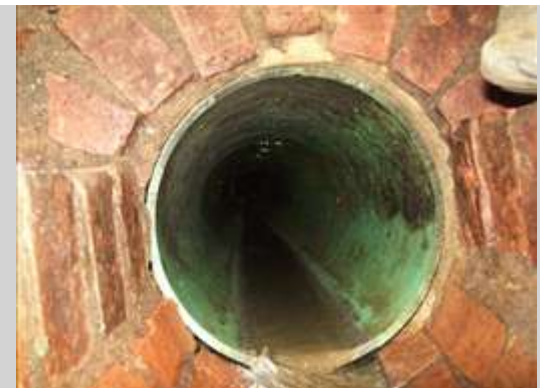
3 O'Clock Inflow

8 in. Circular Gravity Sewer
Pipe In @ 3 O'Clock

Pipe Material: **PVC** ☐ Pipe Lined

Invert Depth: **13.88** (ft.) Flow Characteristics: **Slow**

Infiltration: **None**

Pipe Seal Cond: **Sound**

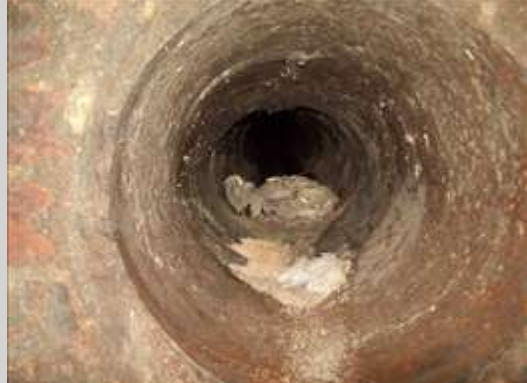
6 O'Clock Inflow

Pipe In @ 6 O'Clock

Pipe Material: **DIP/CI** ☐ Pipe Lined

Invert Depth: **10.90** (ft.) Flow Characteristics: **Slow**

Infiltration: **None**

Pipe Seal Cond: **Sound**

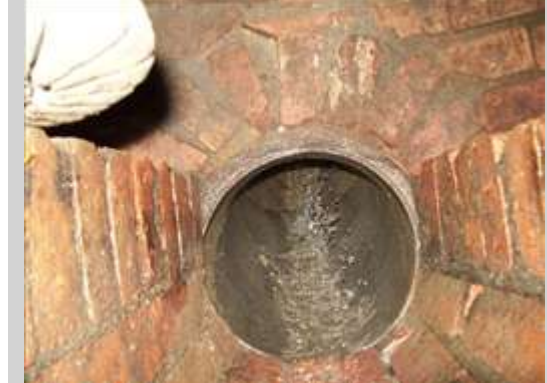
Drop In @ 6 O'Clock

Drop: **Inside** **Direct**

Inv Depth: **13.82** (ft.)

Drop Condition: **Open**
